Excavations in Condercum Vicus (Benwell): Dorcas & Jennison Avenues Summer 2017

The 2017 Excavation

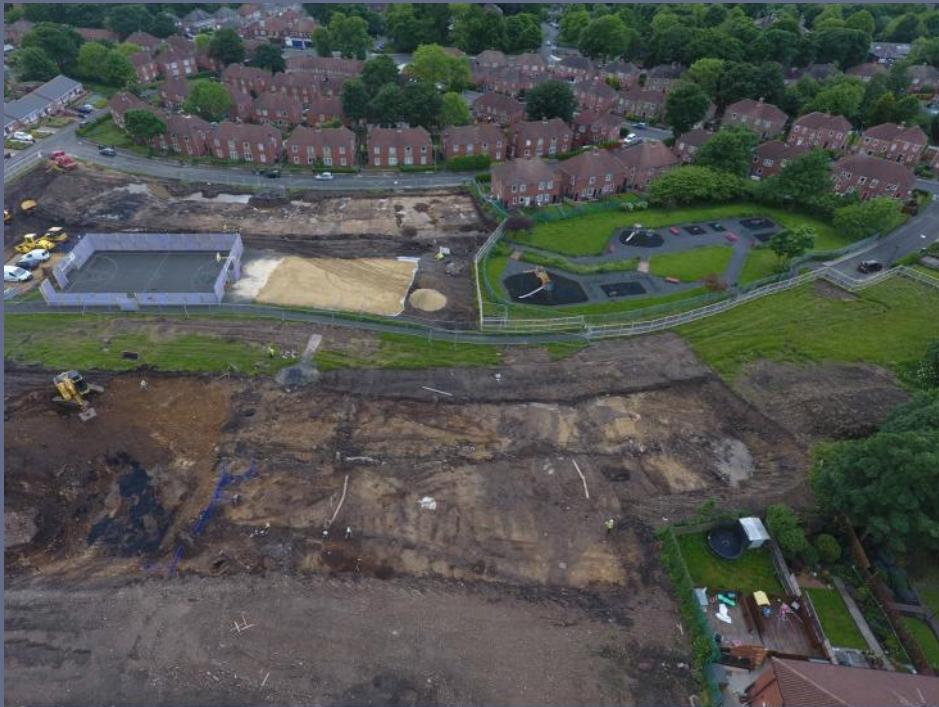
Aerial view looking south, showing the north and south excavation areas

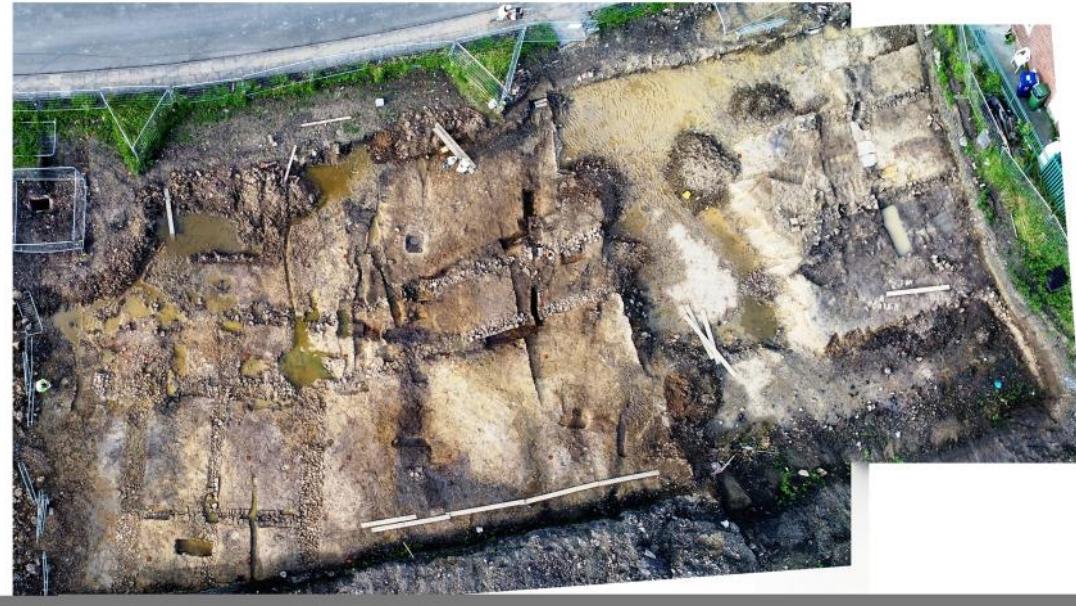
Strip building 1 viewed from the NW

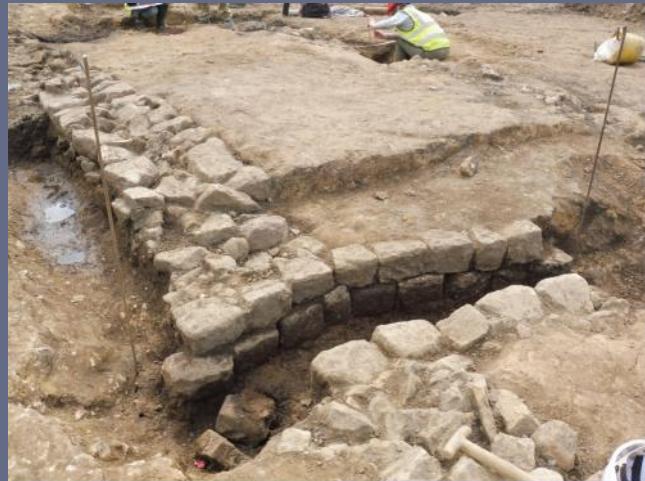
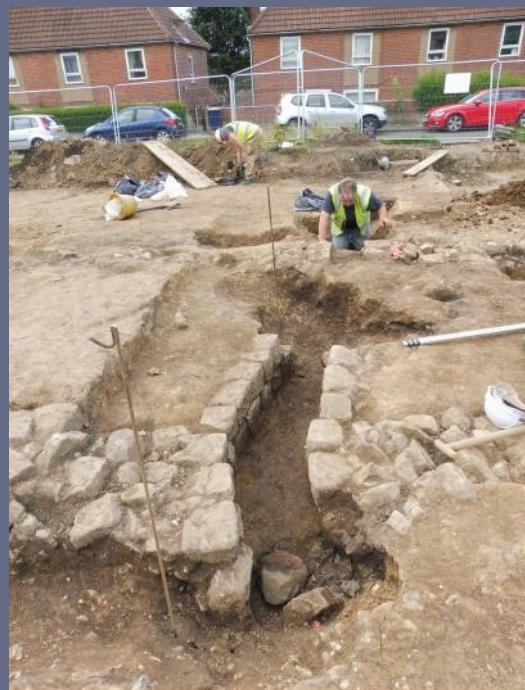
Vicus building 2

Views of the long narrow Building 2, showing the stone-lined drain bisecting it from north to south.

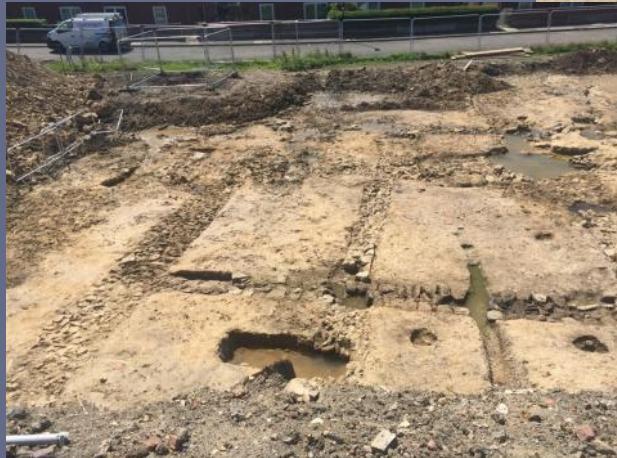
View of Building 3 looking south, with E wall, central spine wall with cobbled foundations, internal post holes and later cross wall evident

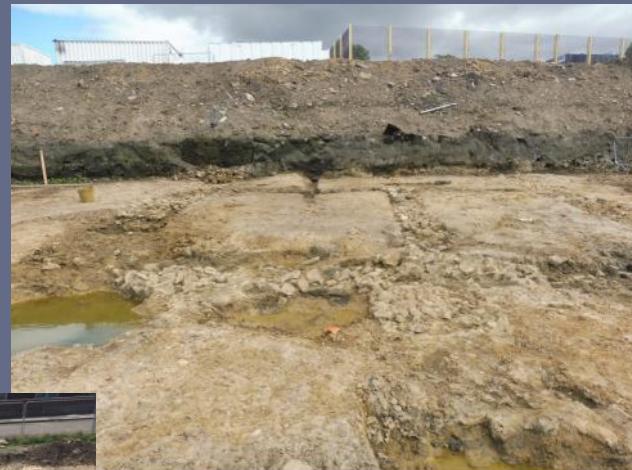
Building 3 viewed from its south end, showing buttressing along the S wall.
